DILLINGHAM AIRPORT

2004 Alaska Airport Pavement Condition Report

Scott Gartin, P.E.
 State Pavement Engineer
 Statewide Materials Section, Alaska DOT&PF
 5800 E. Tudor Road
 Phone: (907) 269-6244 Fax: (907) 269-6231
 Email: scott_gartin@dot.state.ak.us

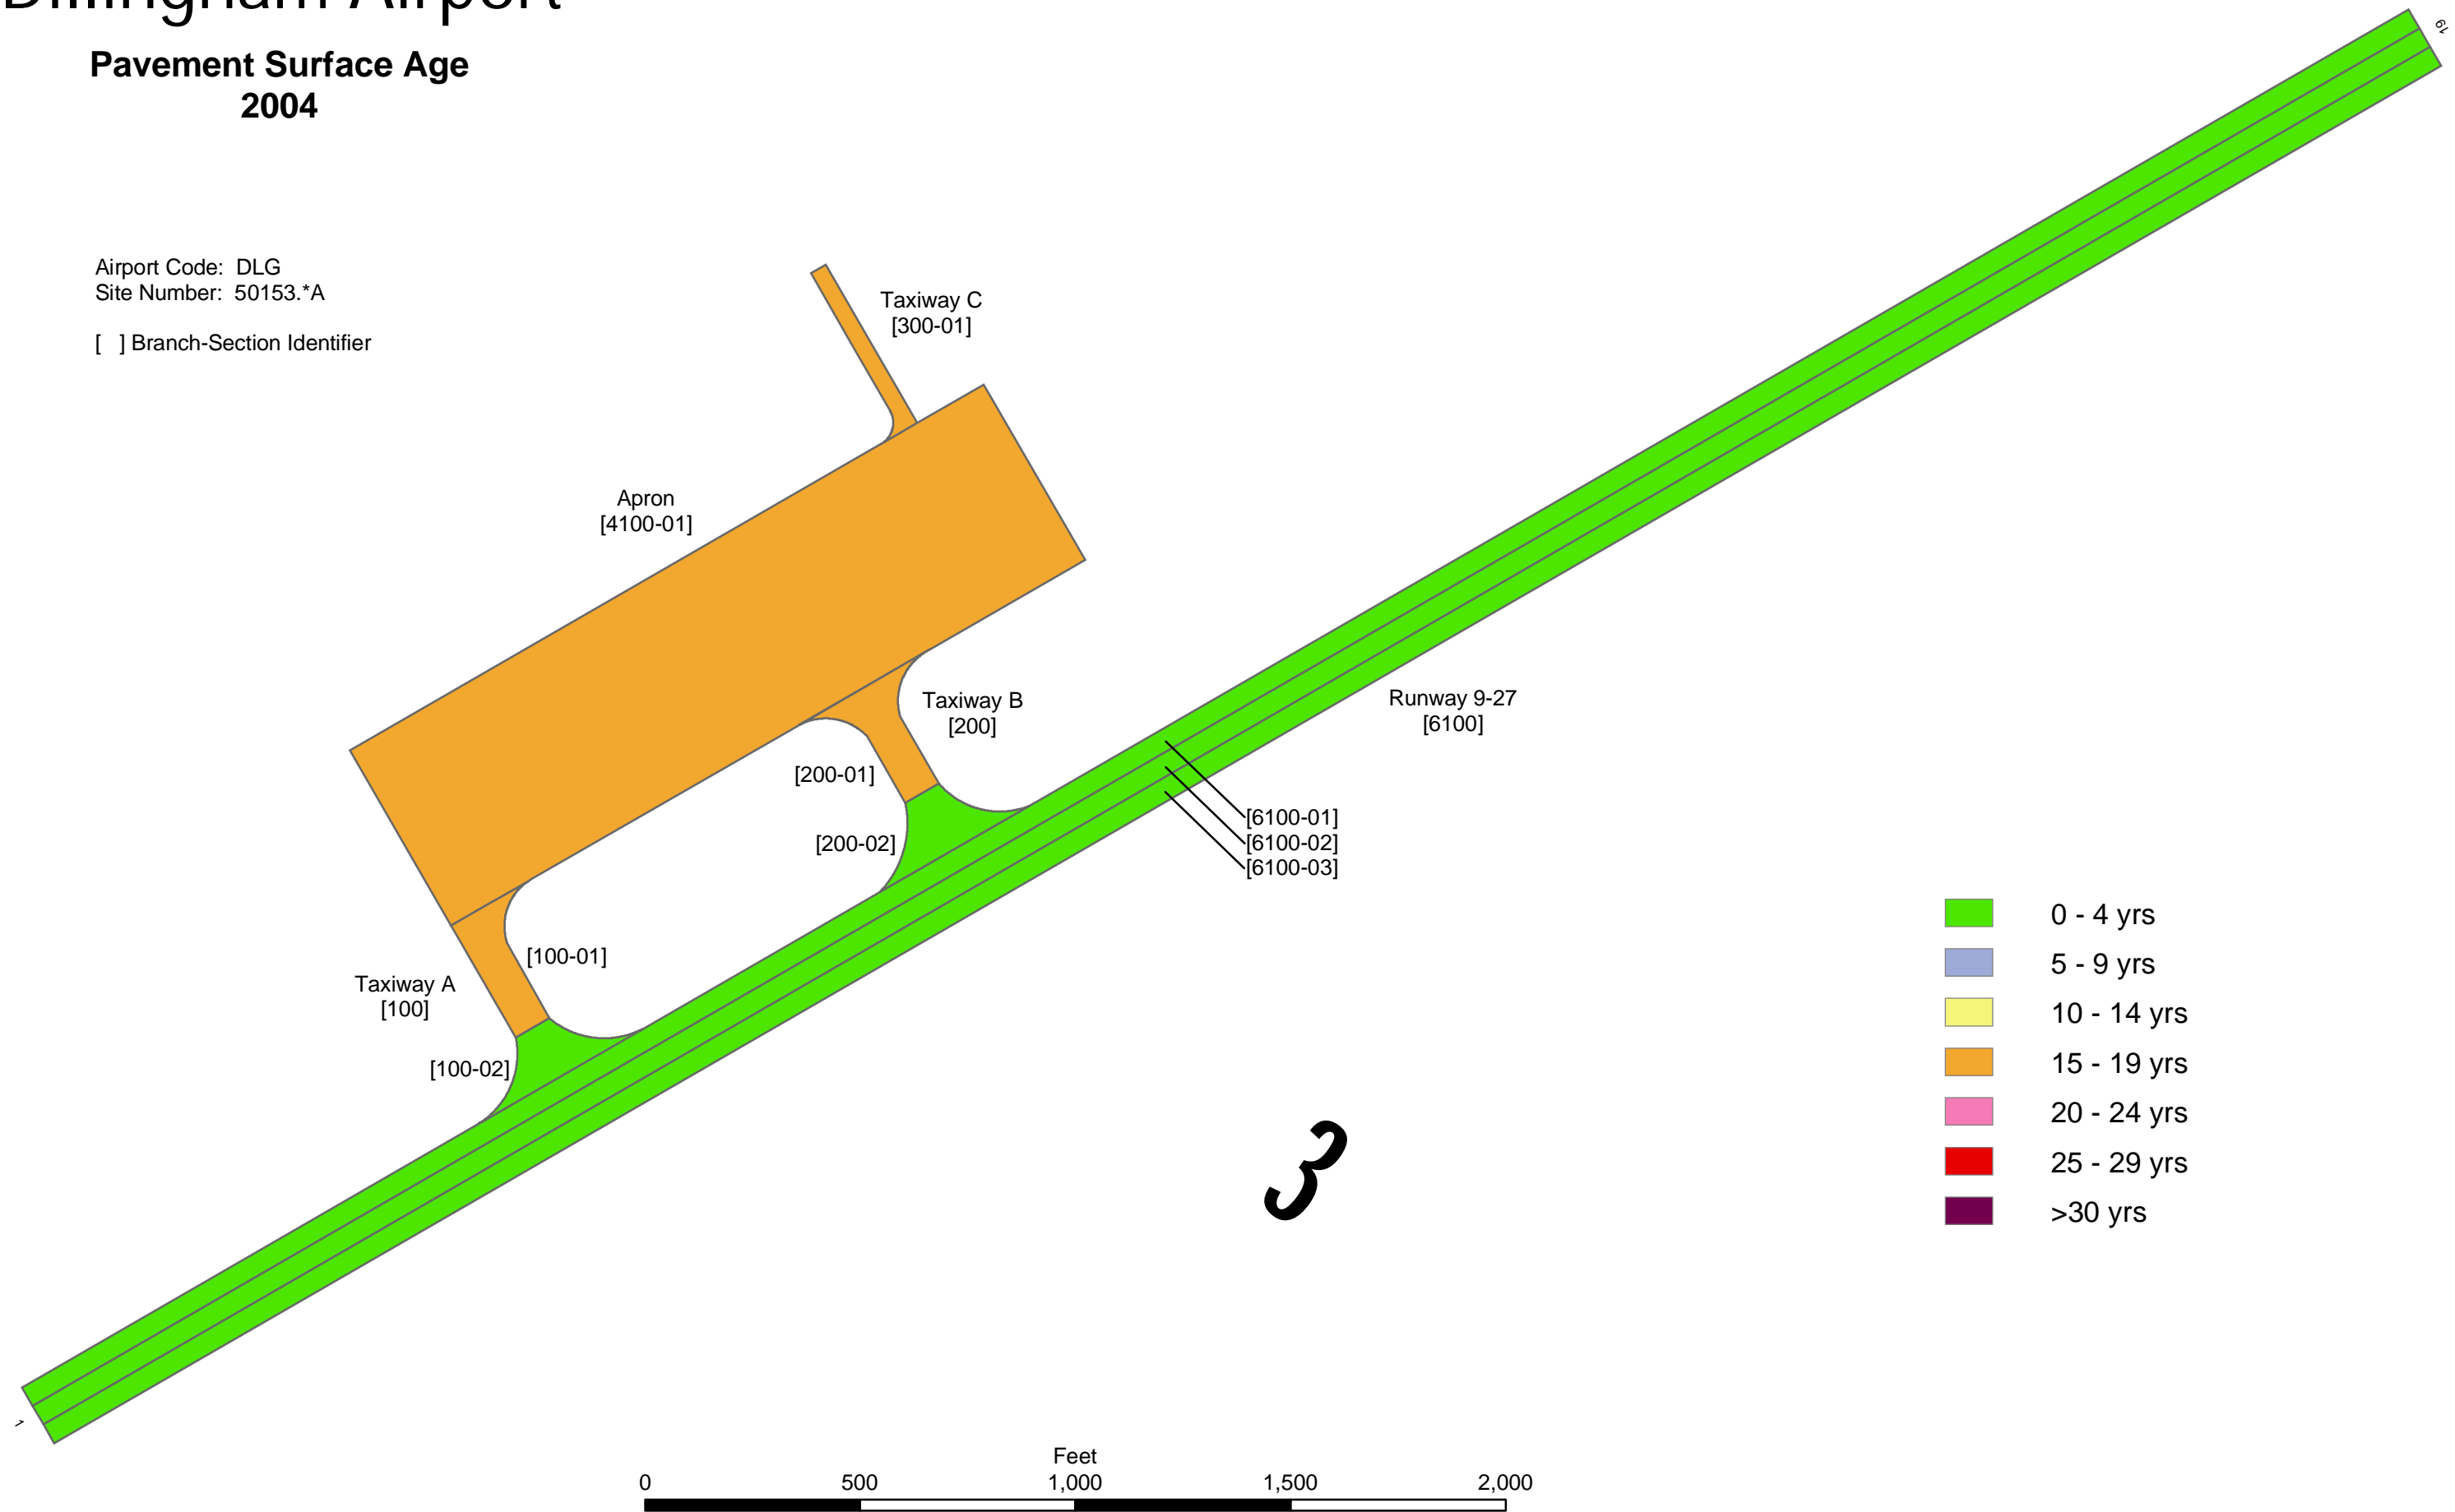
Pavement Condition Index (PCI) Measured Values for the Year 2004

- 2004 reported pavement maintenance and/or changed conditions: The runway pavement that was reconstructed and small portions of taxiways and Main Apron pavement patched in 2003 are performing well. No maintenance was done on the airport pavement in 2004.

- **Recommendations:** See PCI maps. Remaining portions of the airport pavement appear in need of rehabilitation or reconstruction. Seal cracks that are greater than ¼" wide and patch with cold mix as required to maintain serviceability.
